Manhole Inspection Summary

Manhole # S29AA1001MH

Insp Date: **12/11/06 2:53 PM**

Location Address: **3458 CRISP ST**

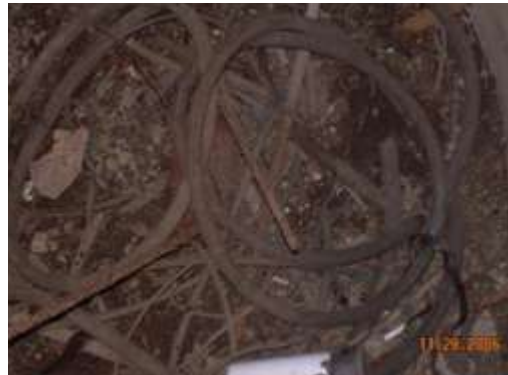
Top View

Channel debris

2' pipe intruding into MH

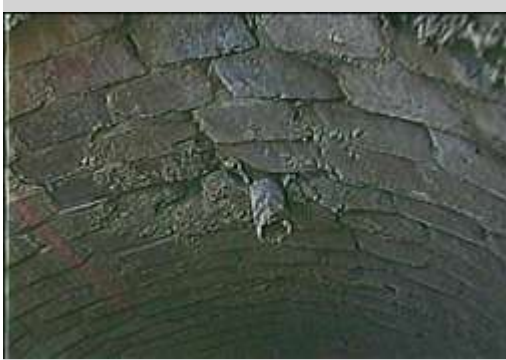
Defect

Corbel deterioration and infiltration.

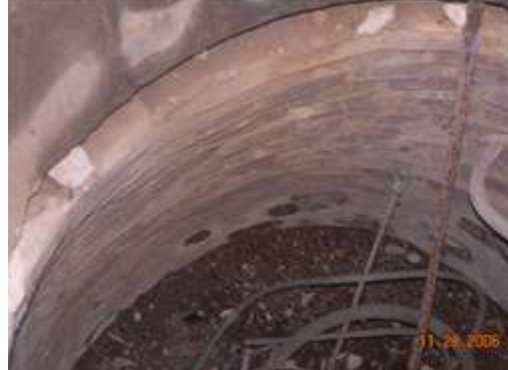
Defect

Frame leaks. Frame offset. Adjustment, Corbel and Barrel infiltration - other side.

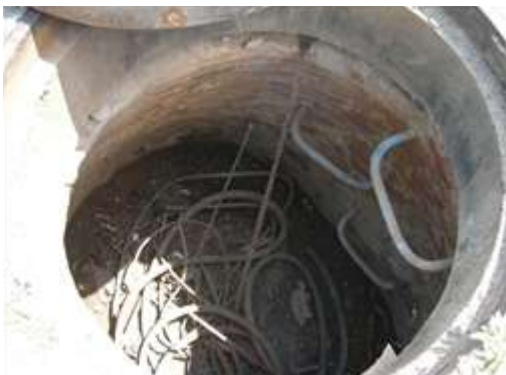
Frame leaks. Frame offset. Adjustment, Corbel and Barrel infiltration.

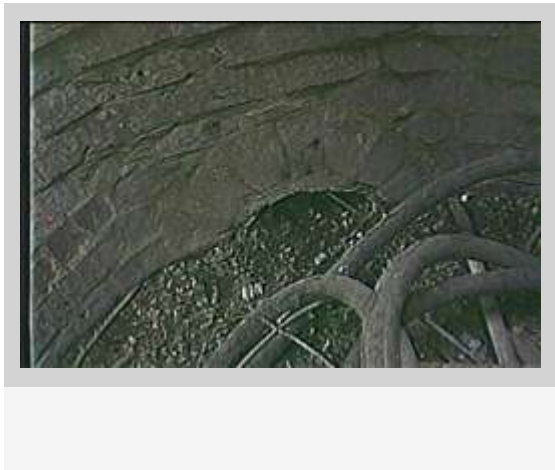
8 in. Circular Gravity Sewer
Pipe Out @ 12 O'Clock

Deposits: ☐ None ☒ **Mud** ☐ Sludge ☒ **Debris** ☐ Grease

Silt Depth: **6** (in.) Deposits Extent: **Heavy**

Infiltration: **Evidence** Pipe Seal Cond: **Cracked**
